# Techniques for quantifying the accumulation of marine debris on beaches

Tomoya Kataoka<sup>1)</sup>, Shin'ichiro Kako<sup>2)</sup>, Cathryn C. Murray<sup>3)</sup>, Charlie Plybon<sup>4)</sup>  
Thomas A. Murphy<sup>5)</sup>, Nir Barnea<sup>6)</sup>, Hirofumi Hinata<sup>7)</sup>, Atsuhiko Isobe<sup>8)</sup>

Purpose: We attempt to quantify the accumulation of marine debris by **aerial photography** and **webcam monitoring** surveys.

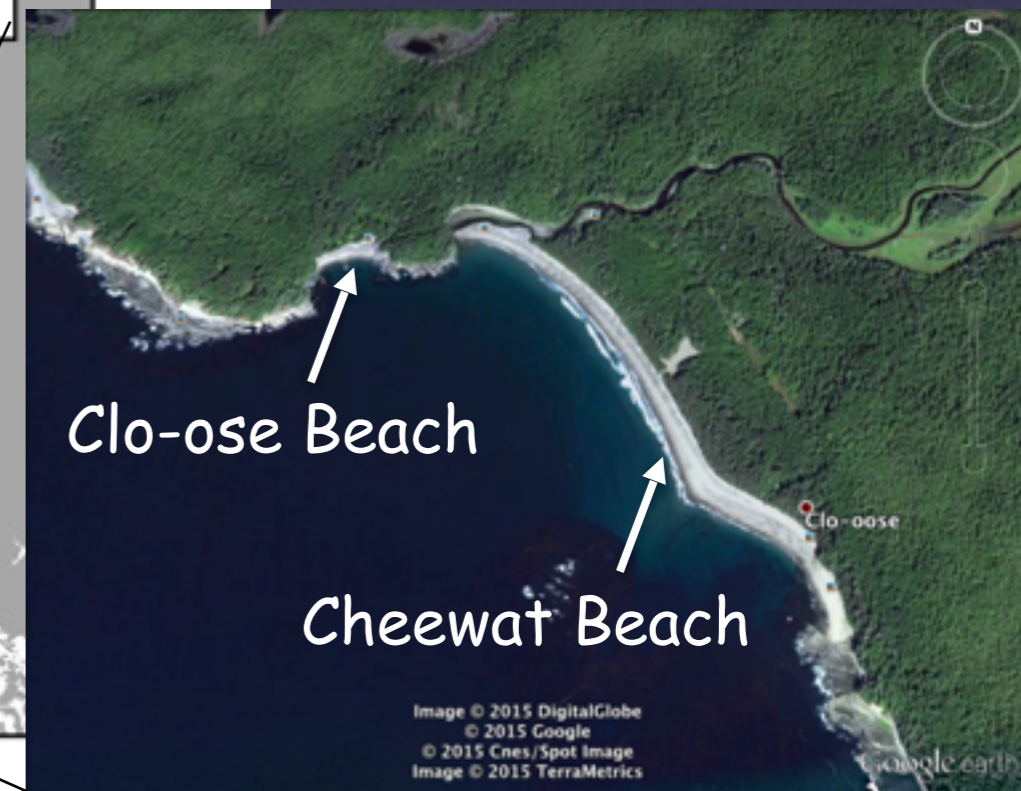
Data for this study

- Aerial photography survey: 2014 surveys (Oct. 7 and Dec. 3, 2014)  
2015 surveys (Jan. 30, Mar. 2 and Jul 28, 2015)
- Shoreline cleanup surveys: Jul. 28, 2015

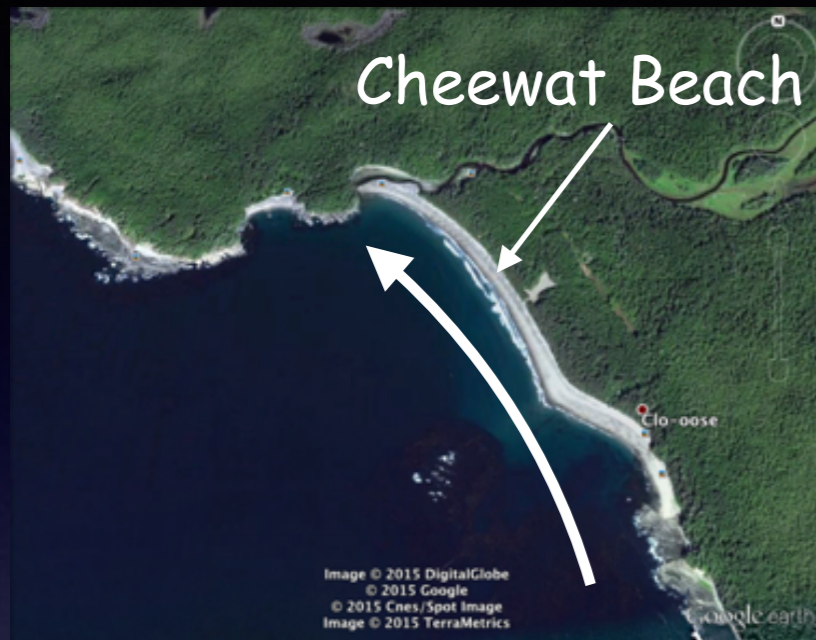
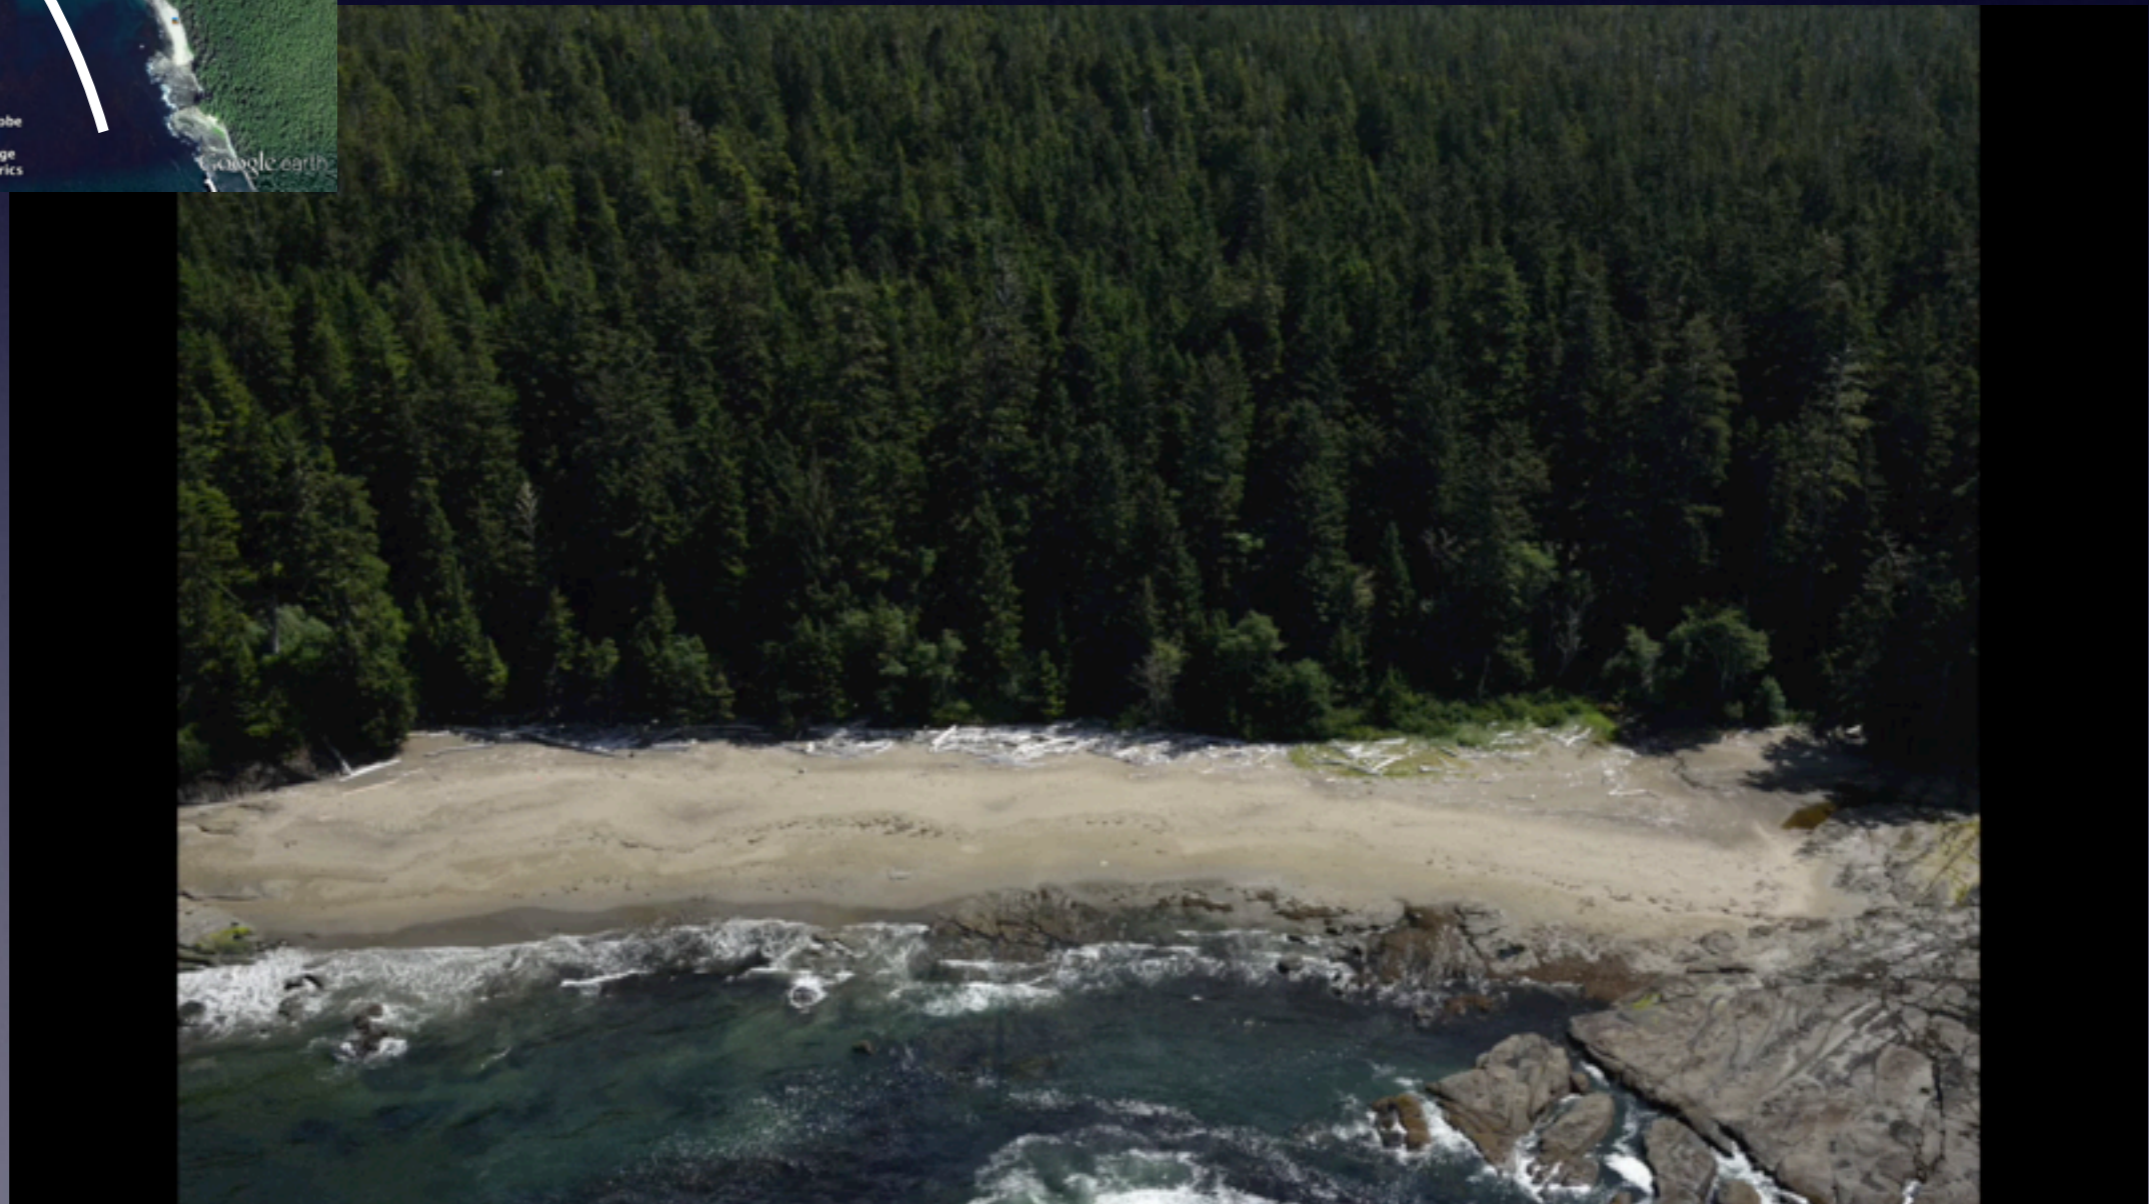
# Aerial photos on Cheewat Beach

Beach length: 1897 m long  
Beach width: 98 m wide (on average)  
Num. of photos: sixteen photos

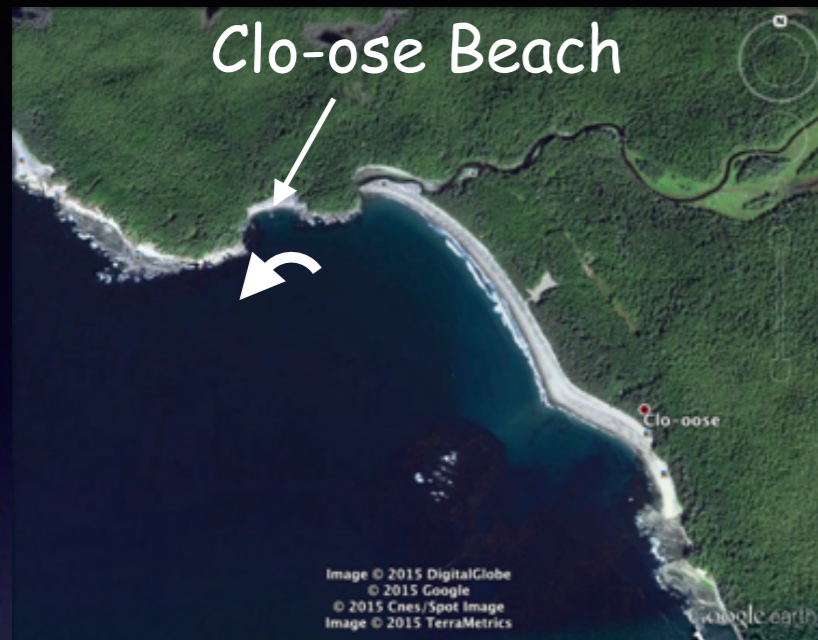
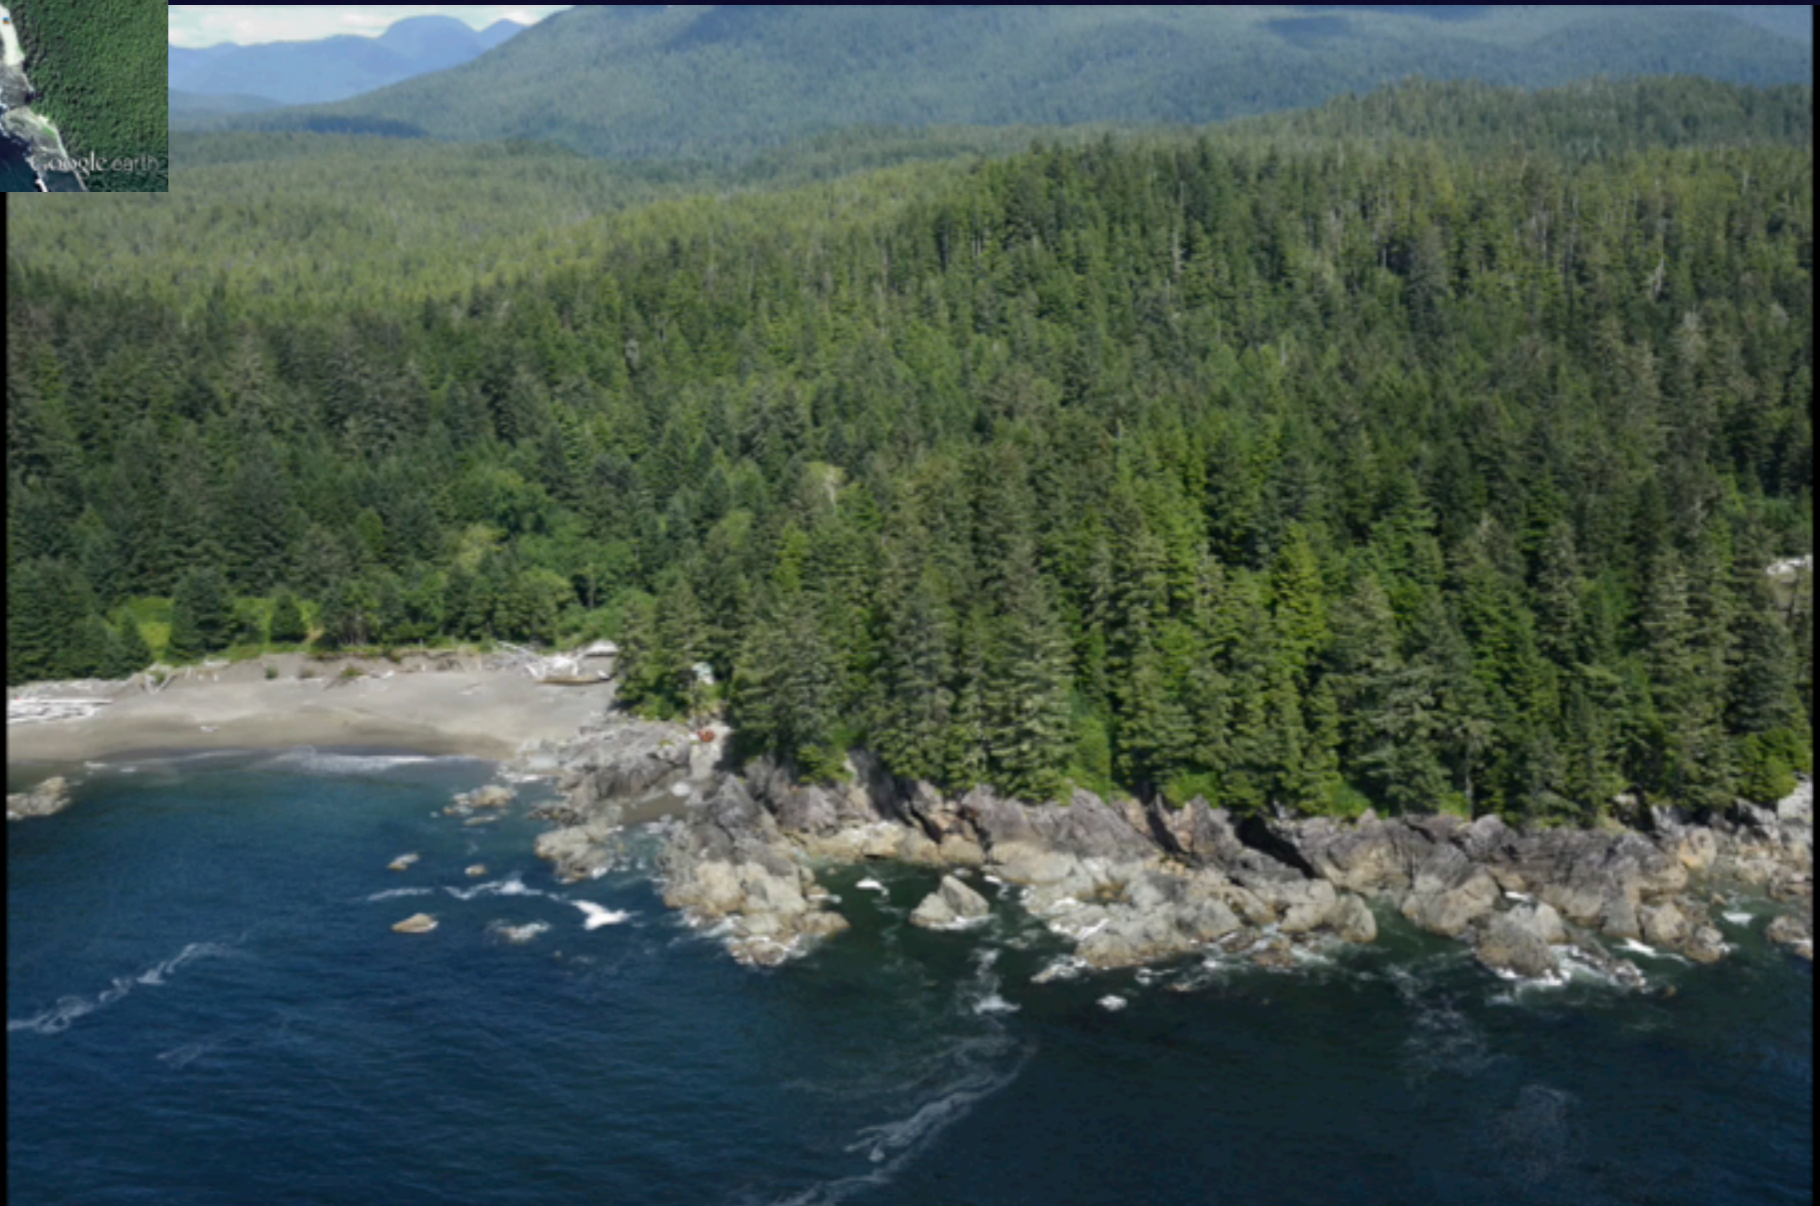
# Aerial photos on Clo-ose Beach

Beach length: 188 m long  
Beach width: 49 m wide (on average)  
Num. of photos: four photos

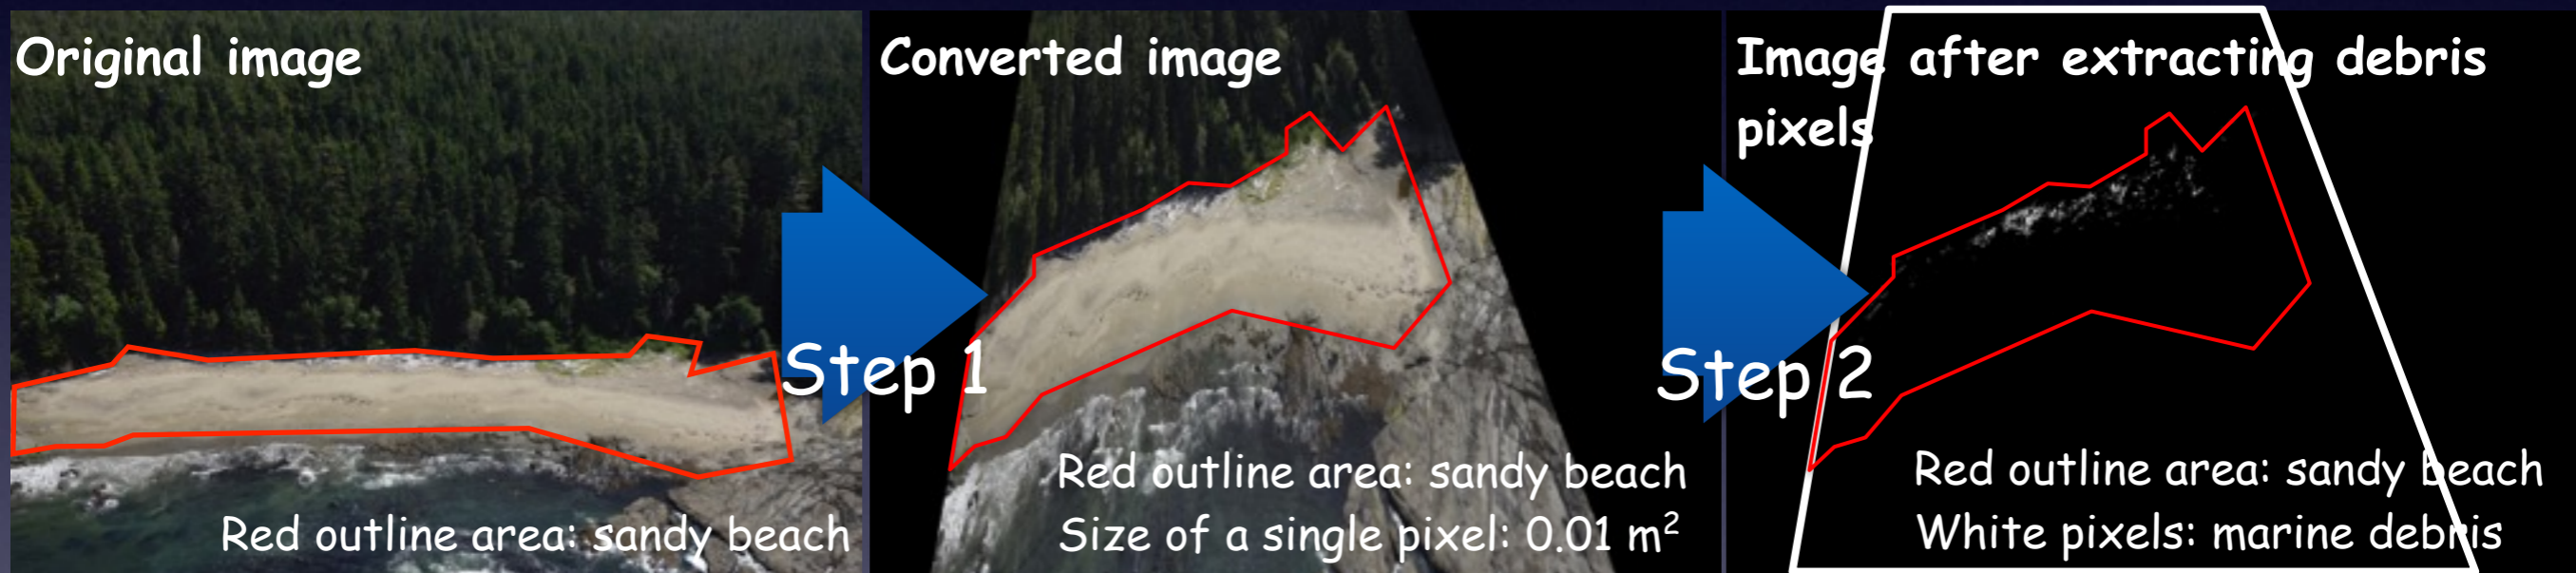
# Procedure of image analysis for quantifying the accumulation

### ▶ percent cover of marine debris

(a ratio of an area covered by marine debris to an area of sandy beach)

Step 1: Removing the distortion of the original image (Magome et al., 2007)

Step 2: Extracting pixels of marine debris (debris pixels)

Step 3: Calculating the percent cover

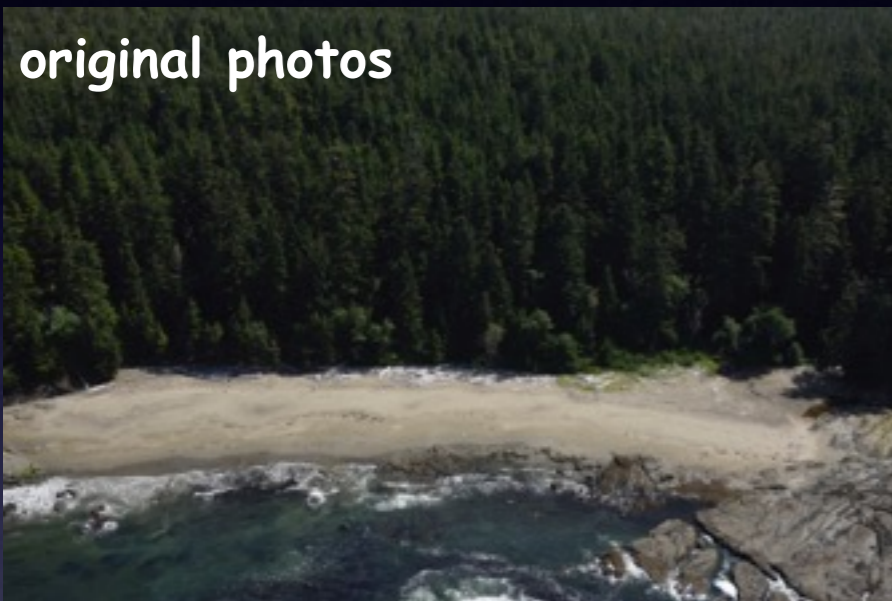
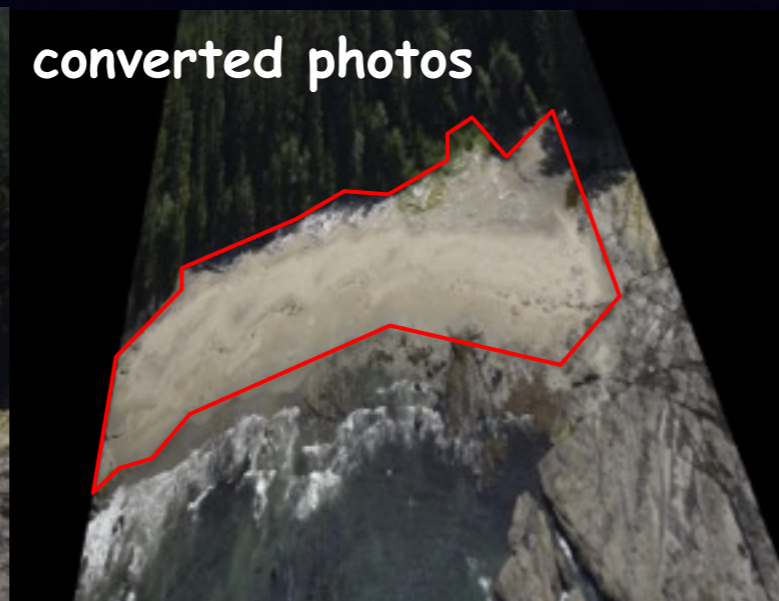
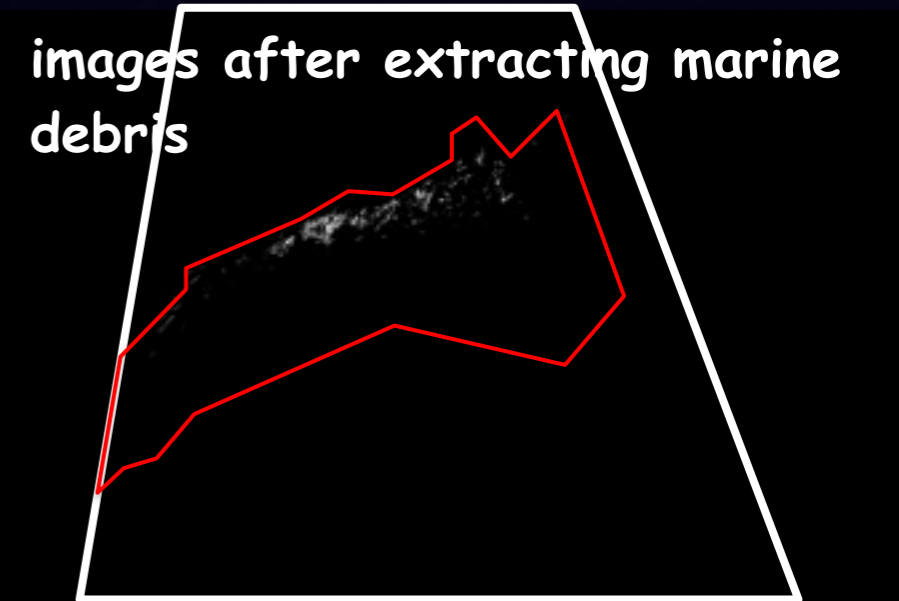
Cheewat Beach → Percent cover of marine debris: 4.0%

Red outline area: sandy beach, White pixels: marine debris

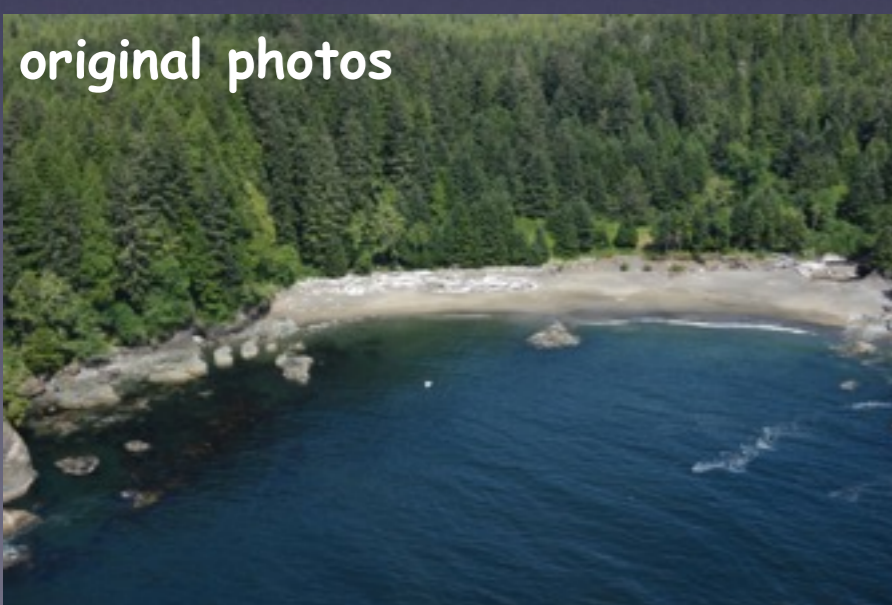
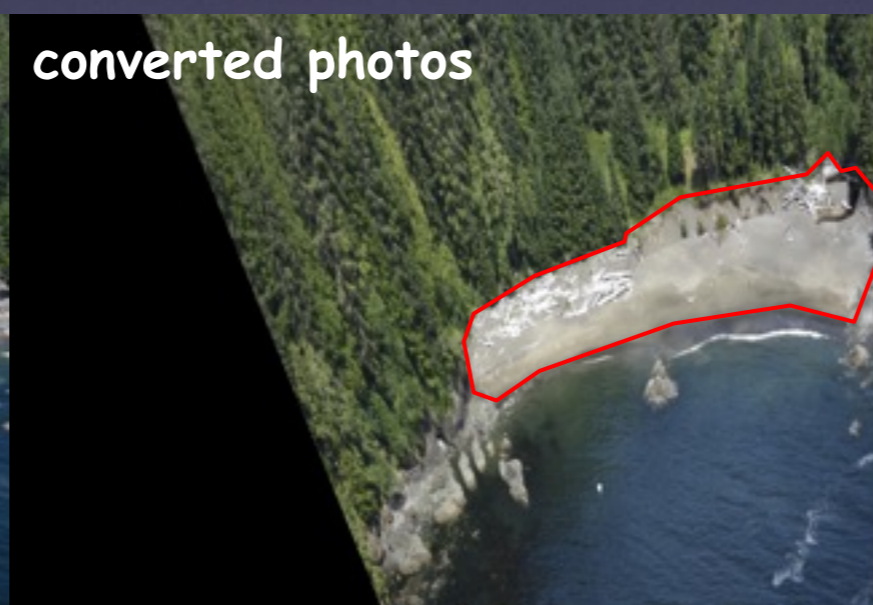
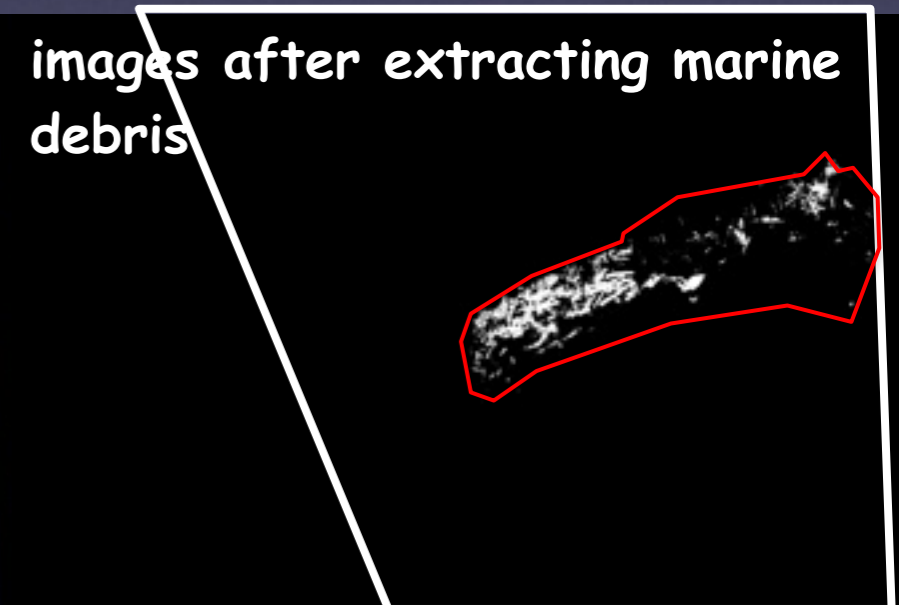
Clo-ose Beach → Percent cover of marine debris: 14.0%

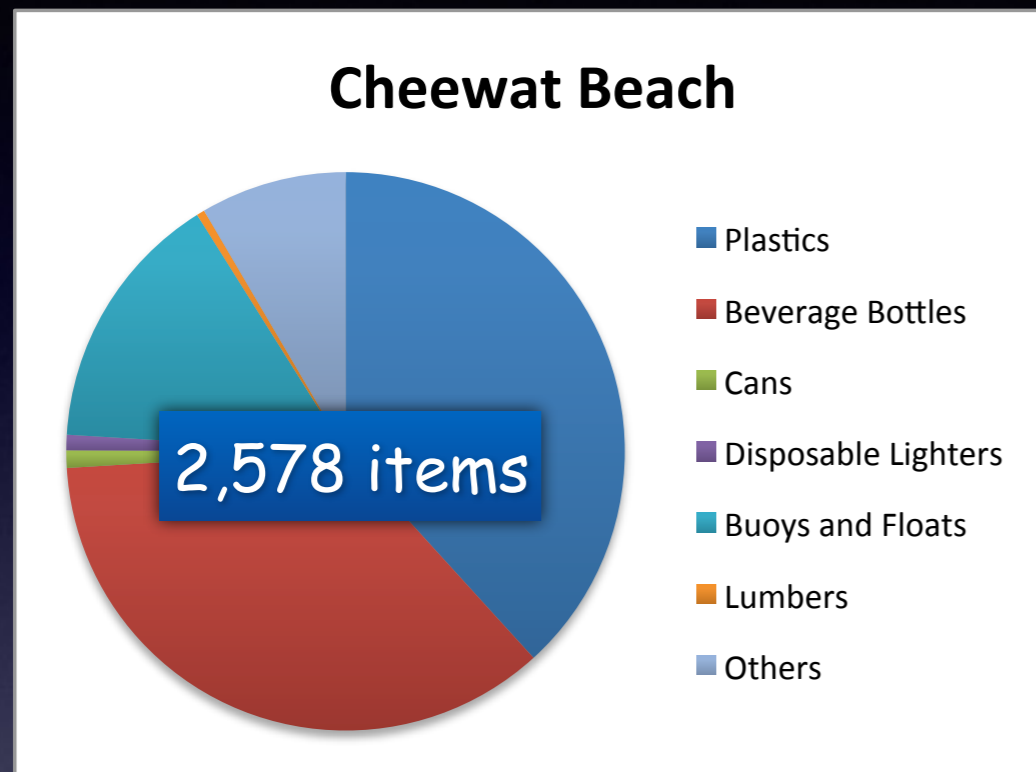
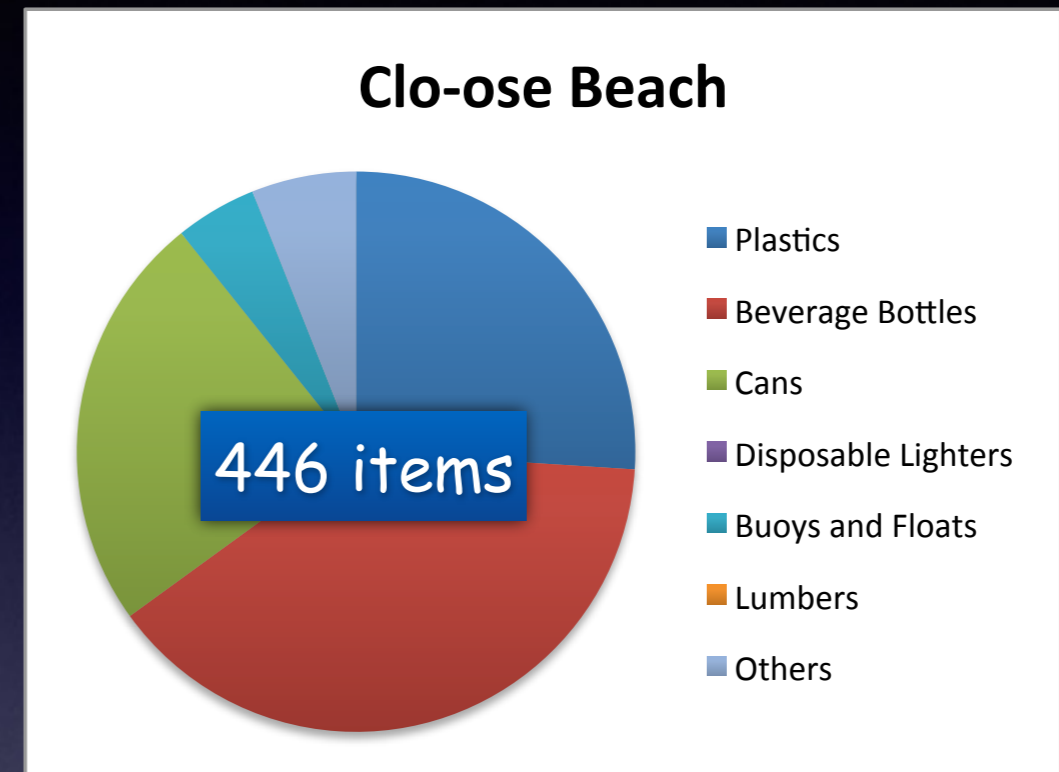
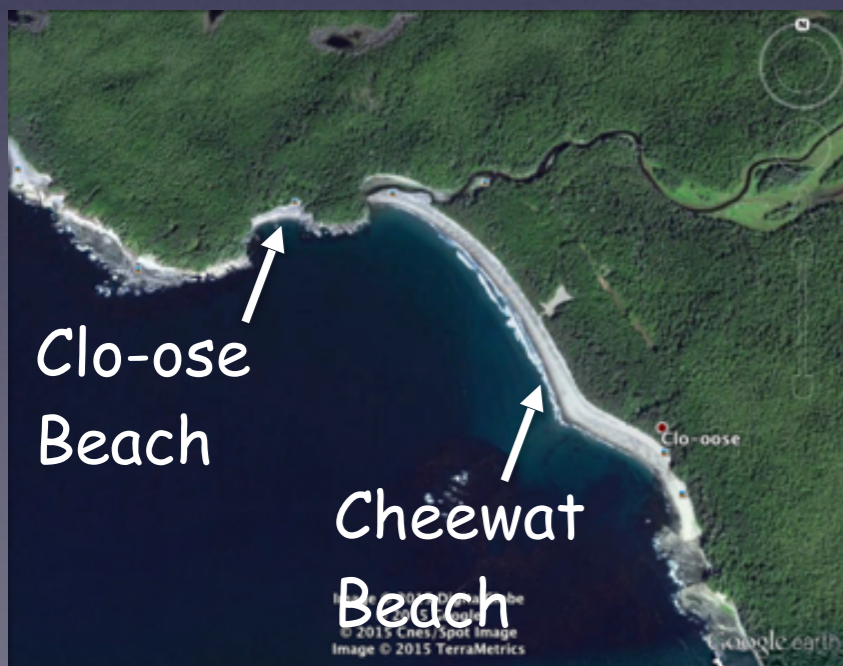
# Results of the shoreline cleanup survey

Beach	Percent cover of marine debris (%)	Density of marine debris (items/100m <sup>2</sup> )
Cheewat Beach	4.0	1.4
Clo-ose Beach	14.0	4.9
Clo-ose / Cheewat	3.5	3.5

- The percent cover estimated from the aerial photographs was consistent with the density of marine debris measured by the shoreline cleanup surveys.
- The estimation of the percent cover would enable us to understand the accumulation of marine debris on multiple beaches.

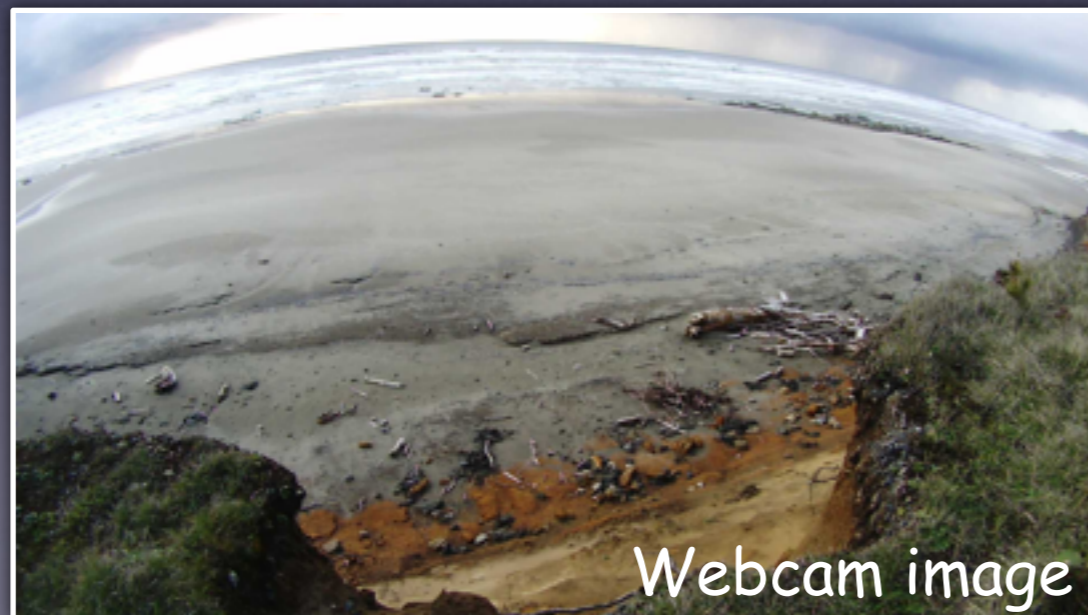
Webcam image

Site: Newport, OR  
Period: Since April 2015- present

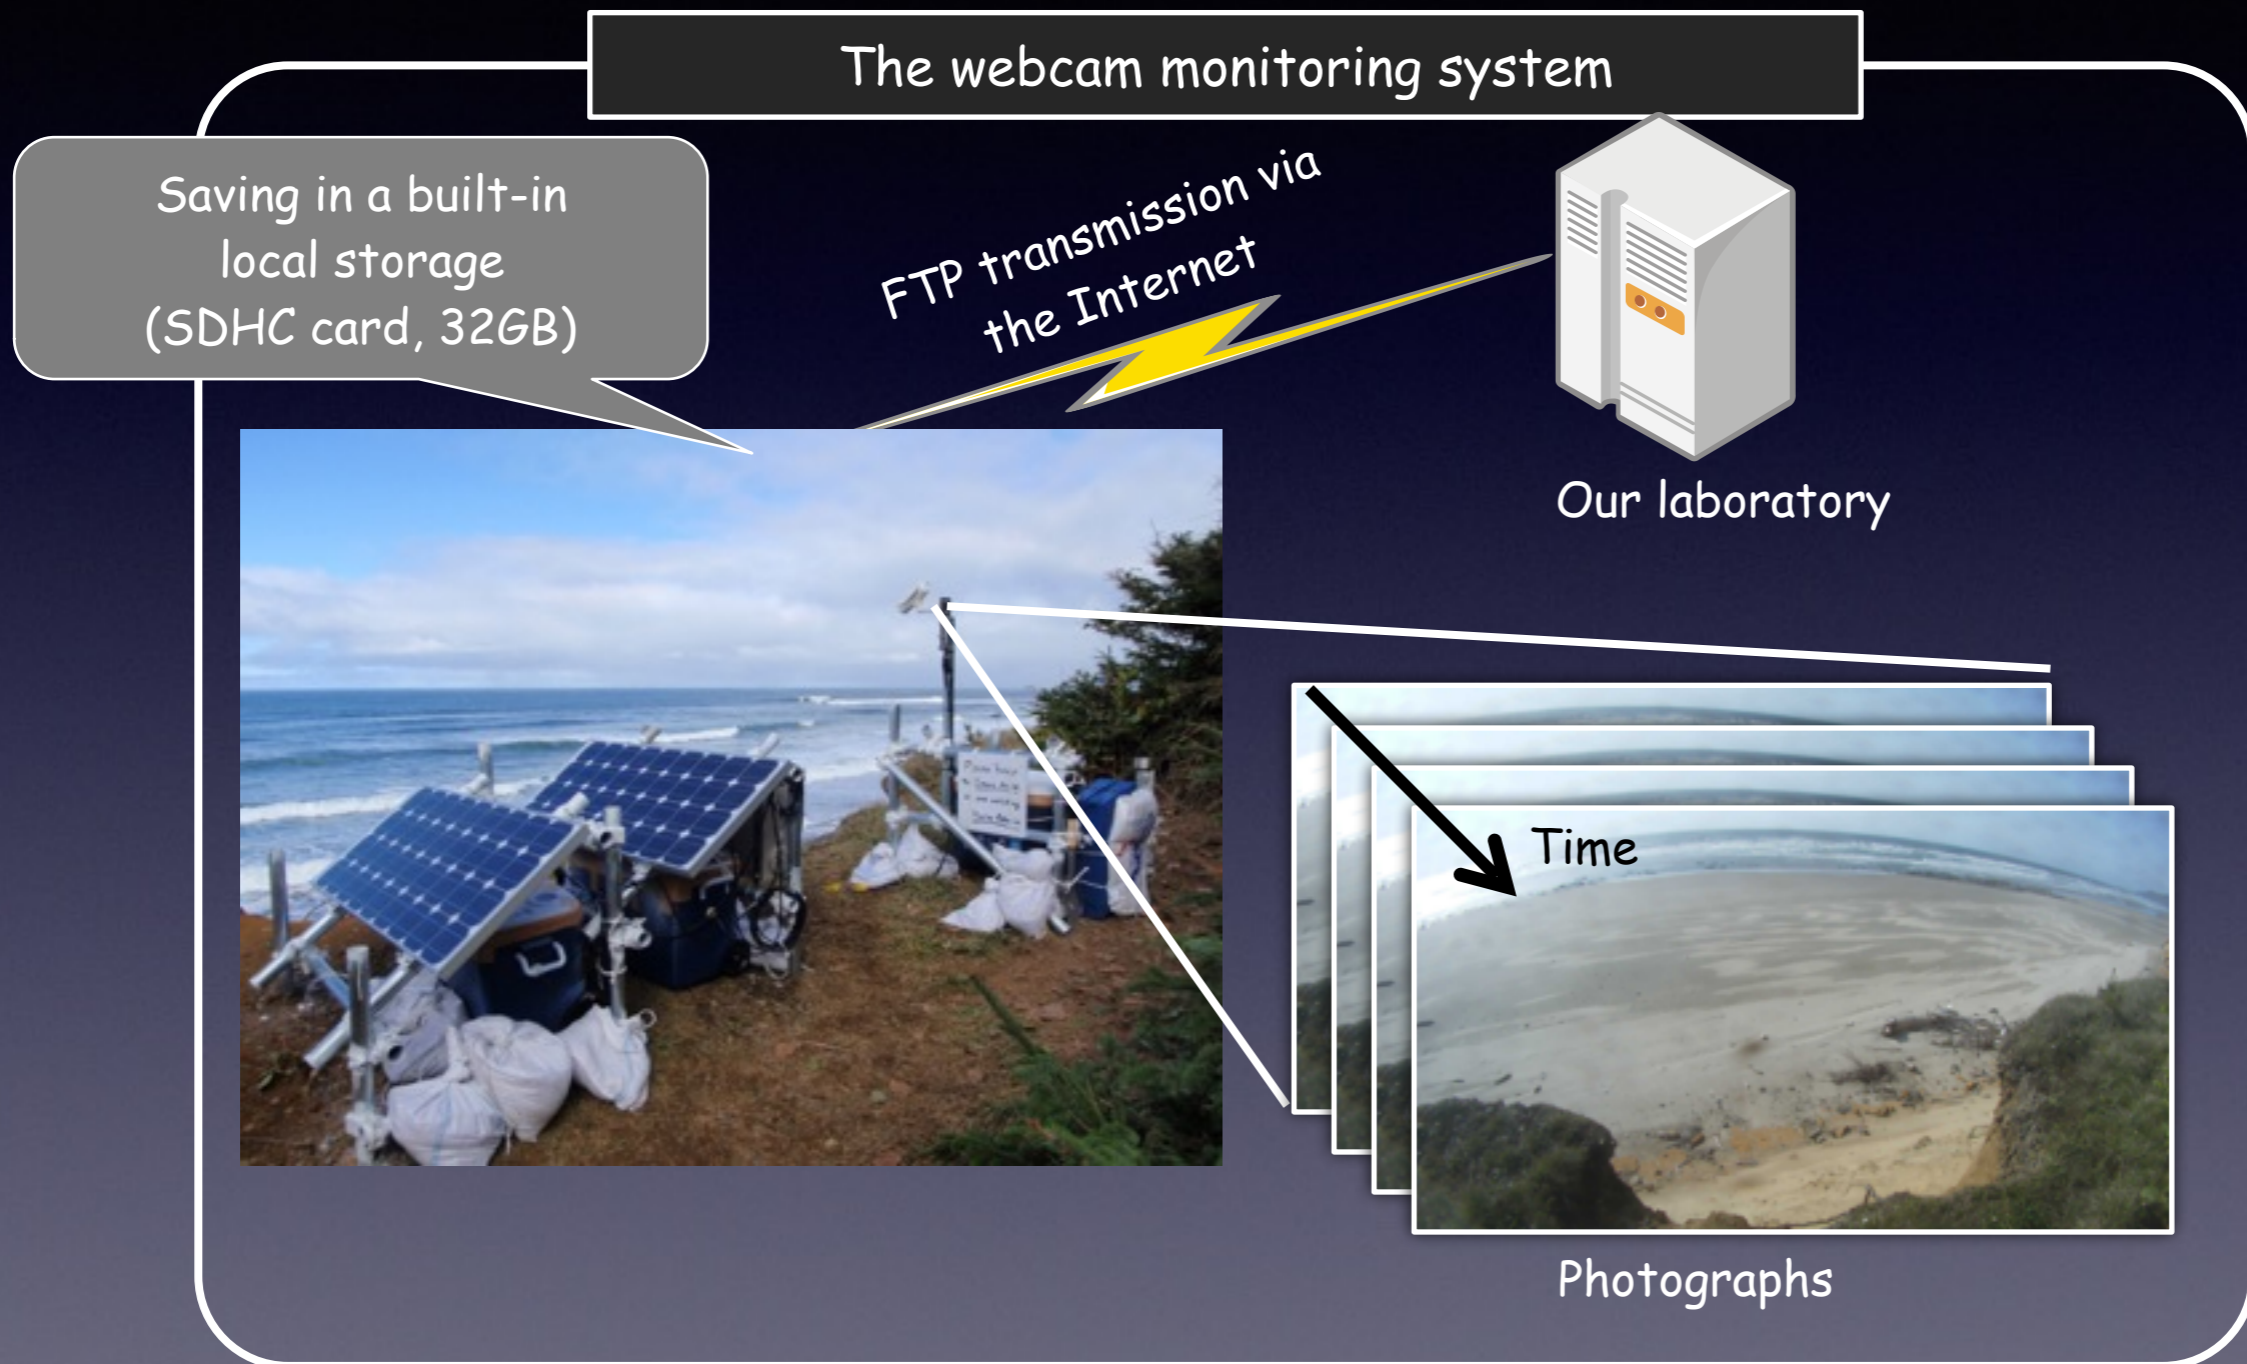
# Our webcam monitoring system

Operation time →  
every one hour from 9:00 to 18:00 PST (i.e., ten times every day)

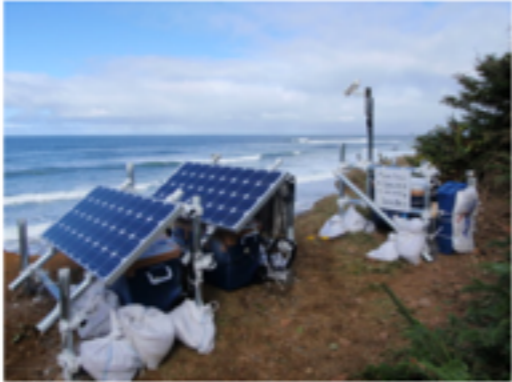
Our webcam system

We are monitoring tsunami debris using a webcam installed on a beach in the Oregon Coast. We will provide quantities of marine debris littered on beaches using the webcam data (Kako et al., *Mar. Pol. Bull.*, 2010; Kataoka et al., *Mar. Pol. Bull.*, 2012). The webcam is operated every one hour for 9:00 to 18:00 (PST), and the webcam data is sent to our server via the Internet. We will put the last webcam data on this website.

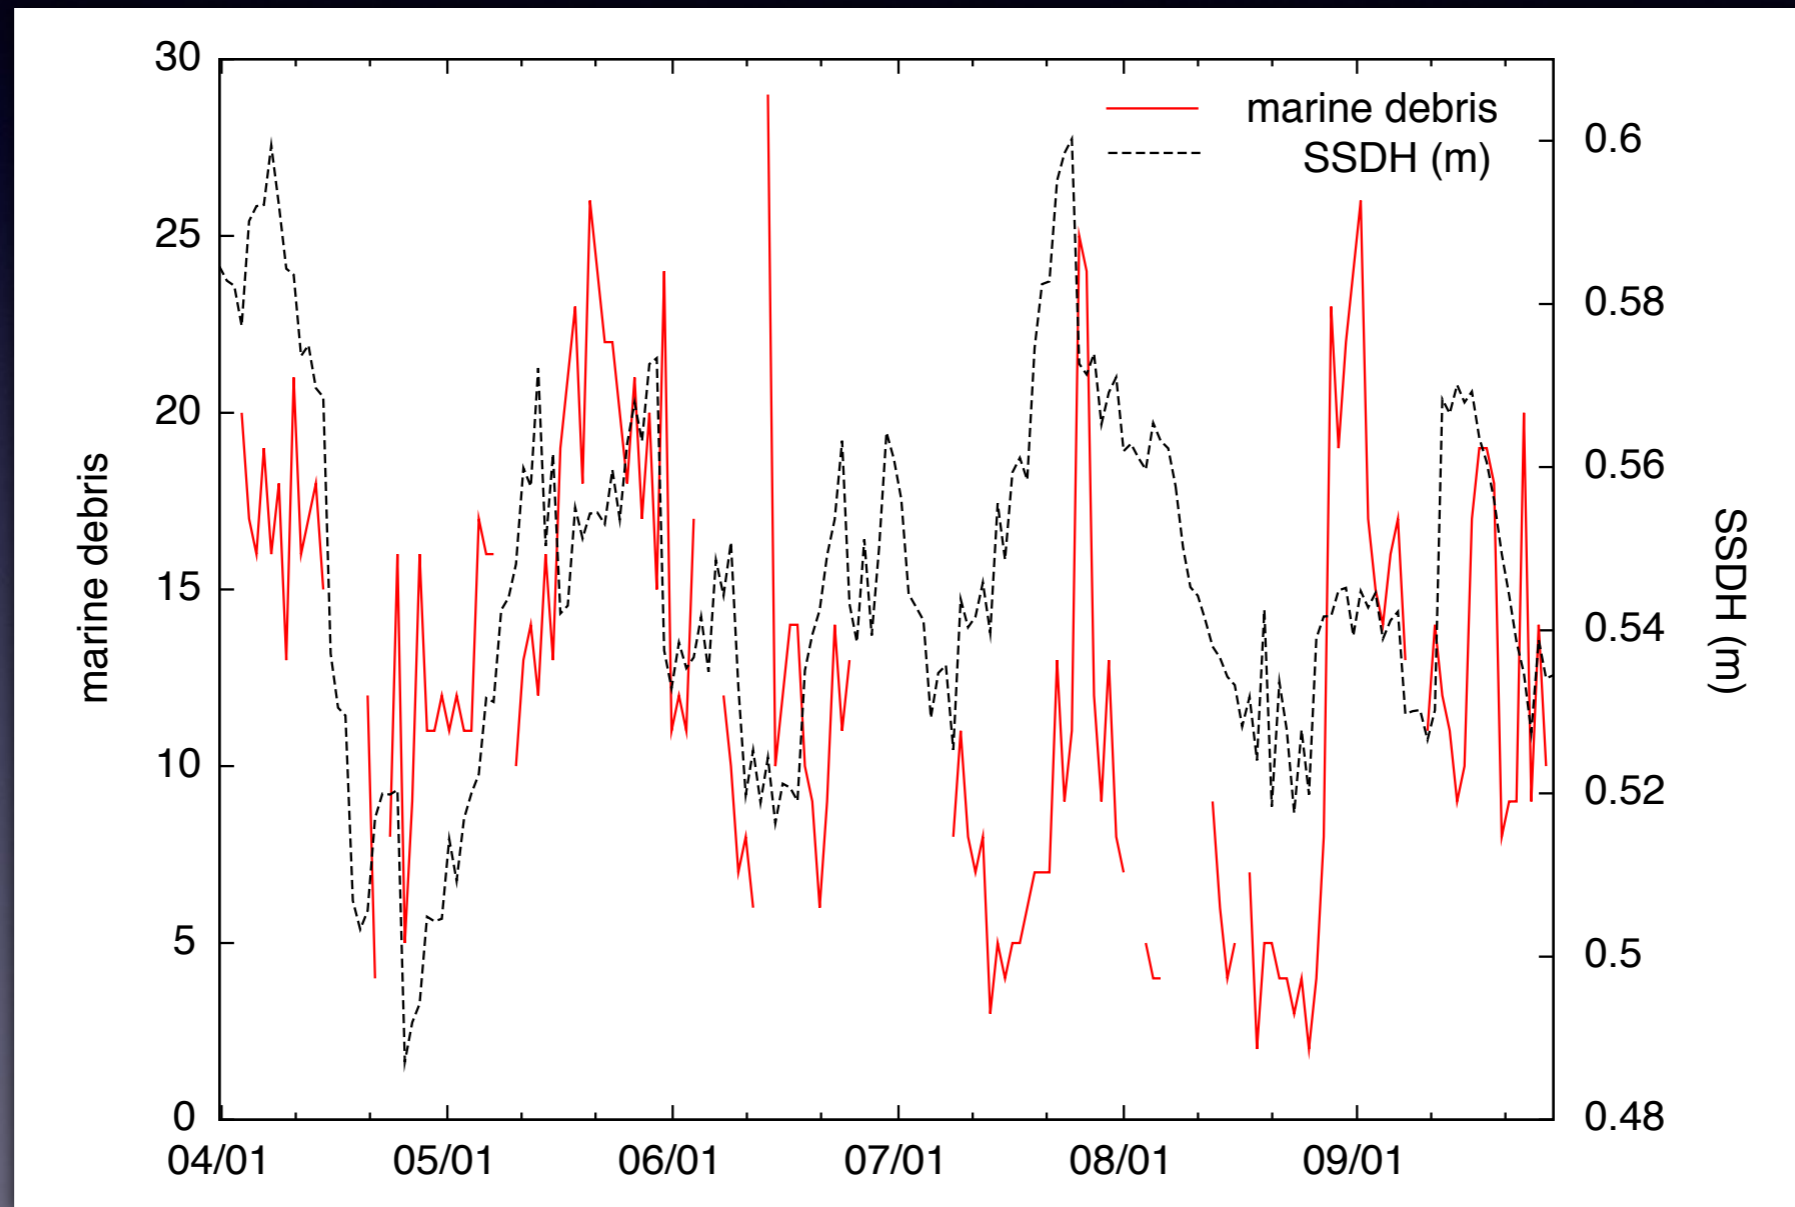
# Comparison with sea surface dynamic height (SSDH)

NOTE: SSDH was produced by Archiving, Validation and interpretation of Satellite Oceanographic data (AVISO)

The number of marine debris decreased (increased) when SSDH was low (high).

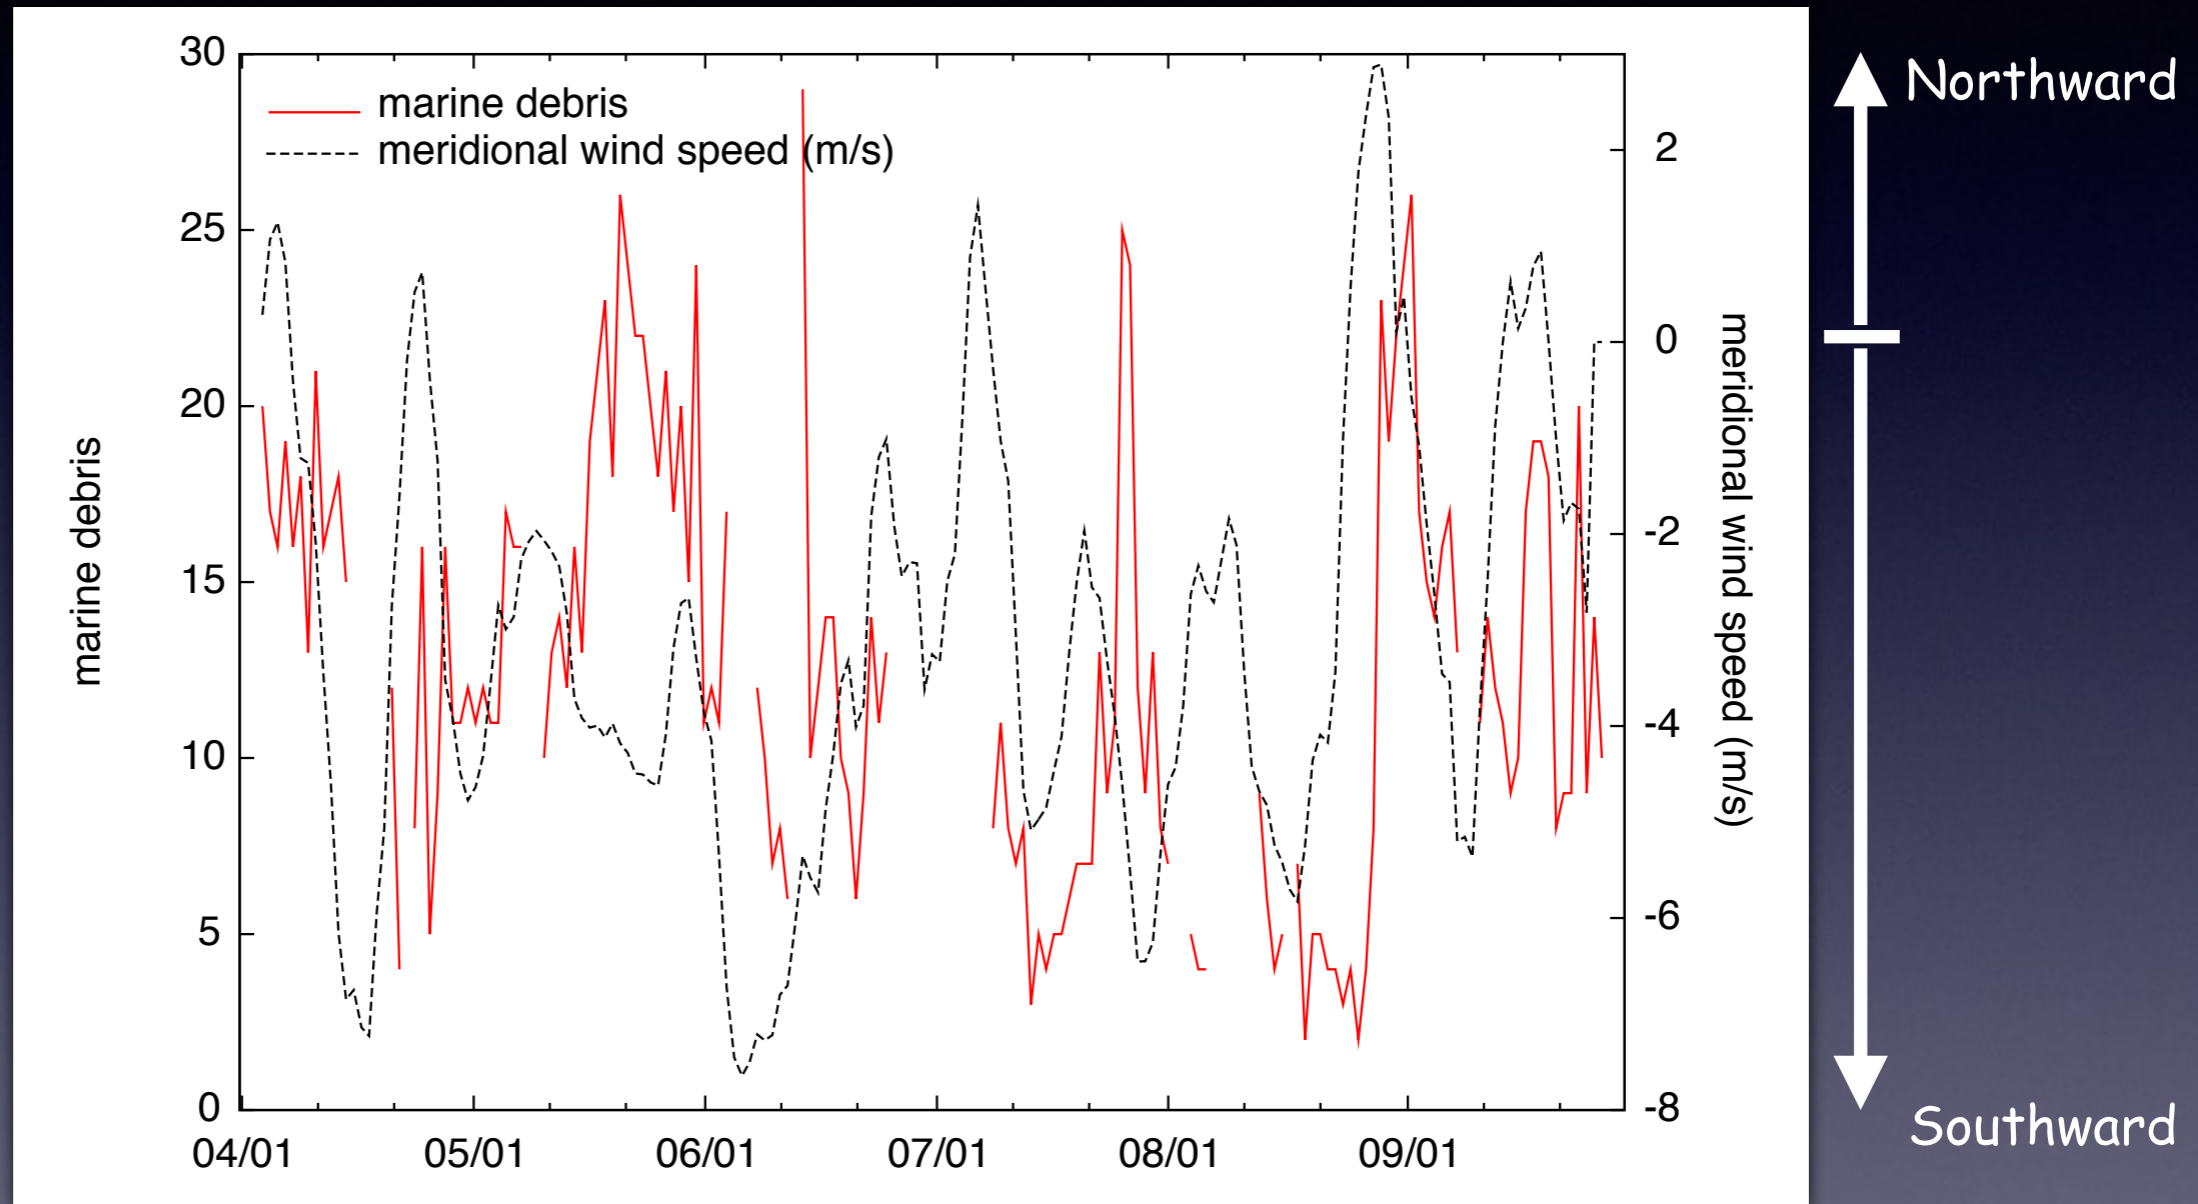
# Comparison with sea surface wind (SSW)

NOTE: SSW was observed by Advanced scatterometer (ASCAT; Kako et al., JGR, 2011)

The number of marine debris decreased (increased) when southward winds intensified (weakened or northward winds blowed).
