# Techniques for quantifying the accumulation of marine debris on beaches

Tomoya Kataoka<sup>1)</sup>, Shin'ichiro Kako<sup>2)</sup>, Cathryn C. Murray<sup>3)</sup>, Charlie Plybon<sup>4)</sup>  
Thomas A. Murphy<sup>5)</sup>, Nir Barnea<sup>6)</sup>, Hirofumi Hinata<sup>7)</sup>, Atsuhiko Isobe<sup>8)</sup>

Purpose: We attempt to quantify the accumulation of marine debris by **aerial photography** and **webcam monitoring** surveys.

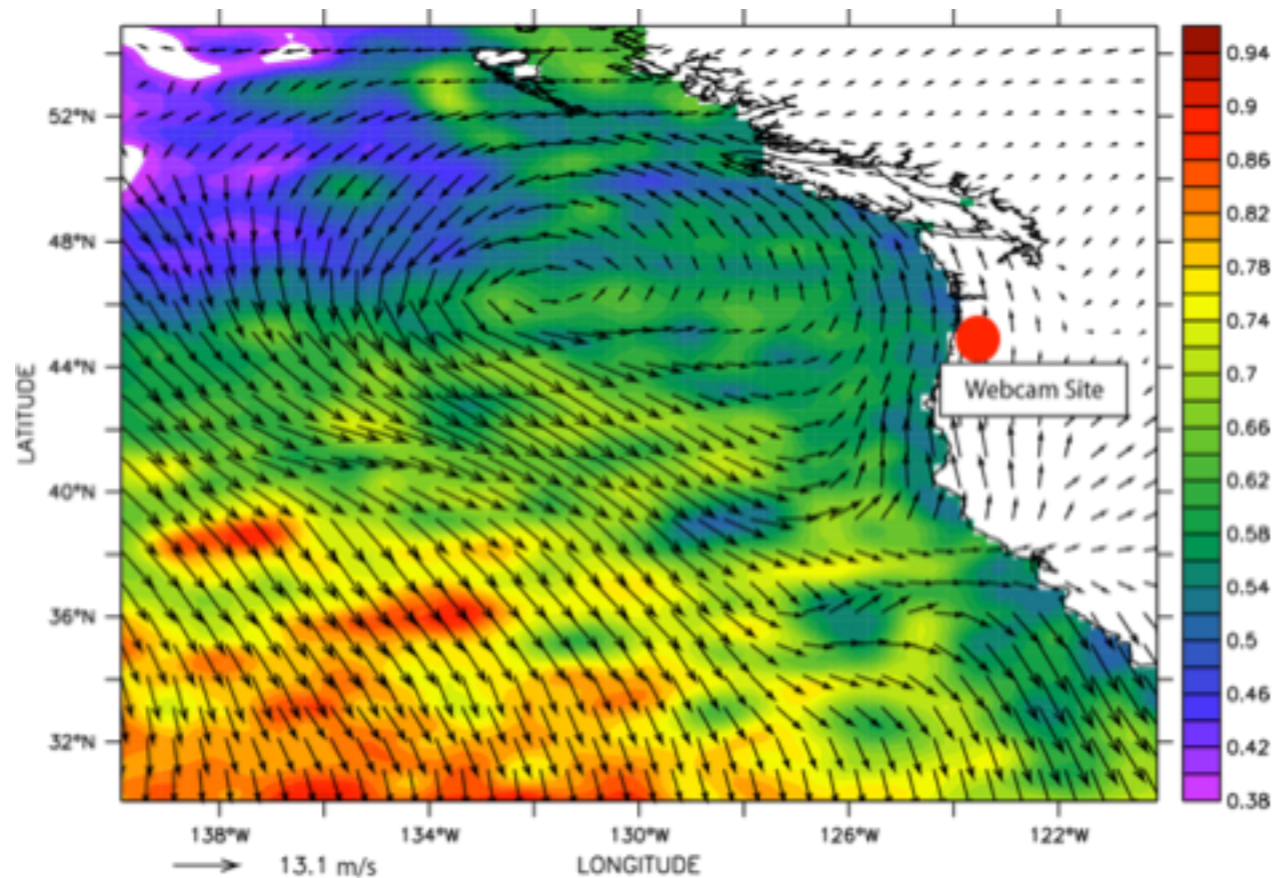
# Horizontal distribution of SSDH and SSW

When the quantity of marine debris increased (on April 5, 2015)

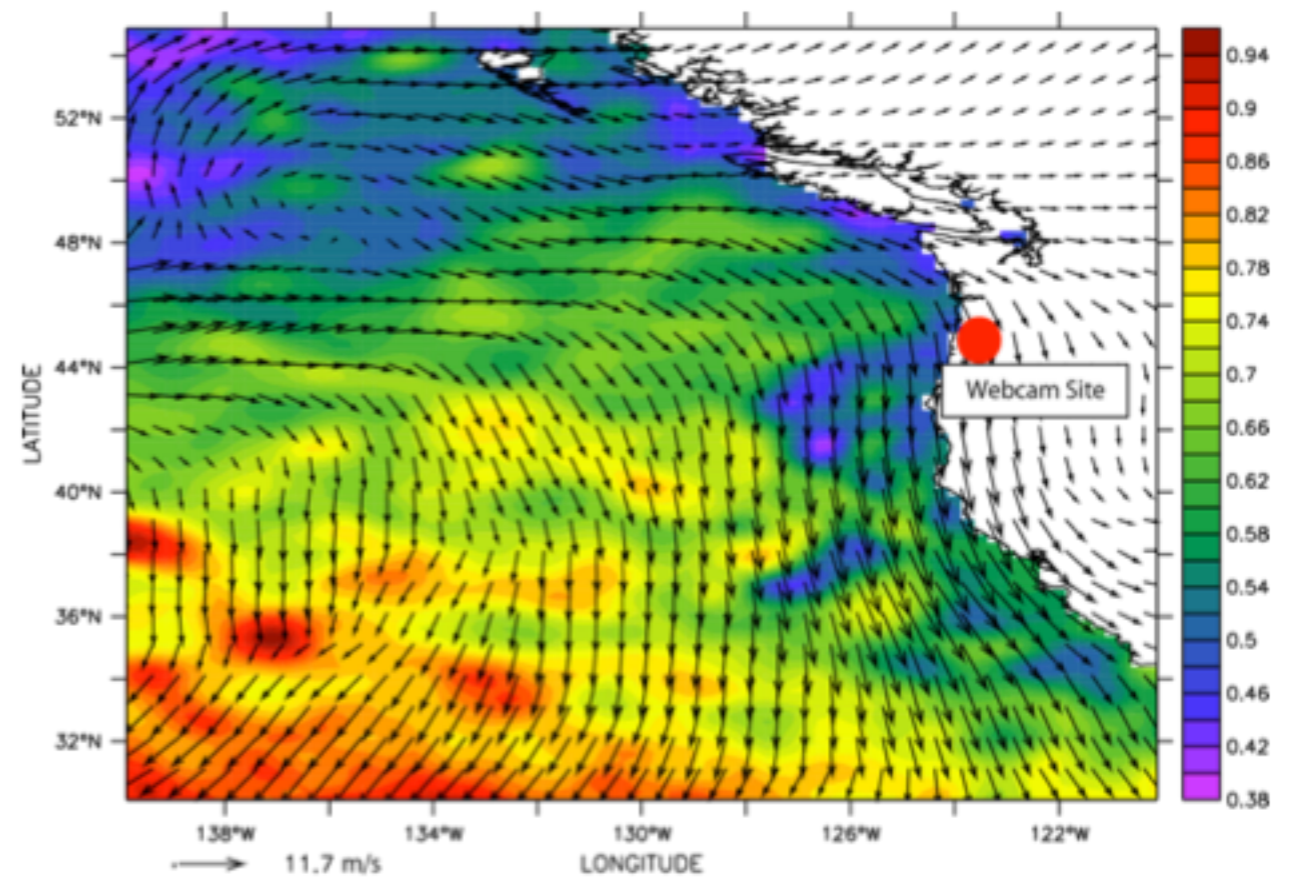
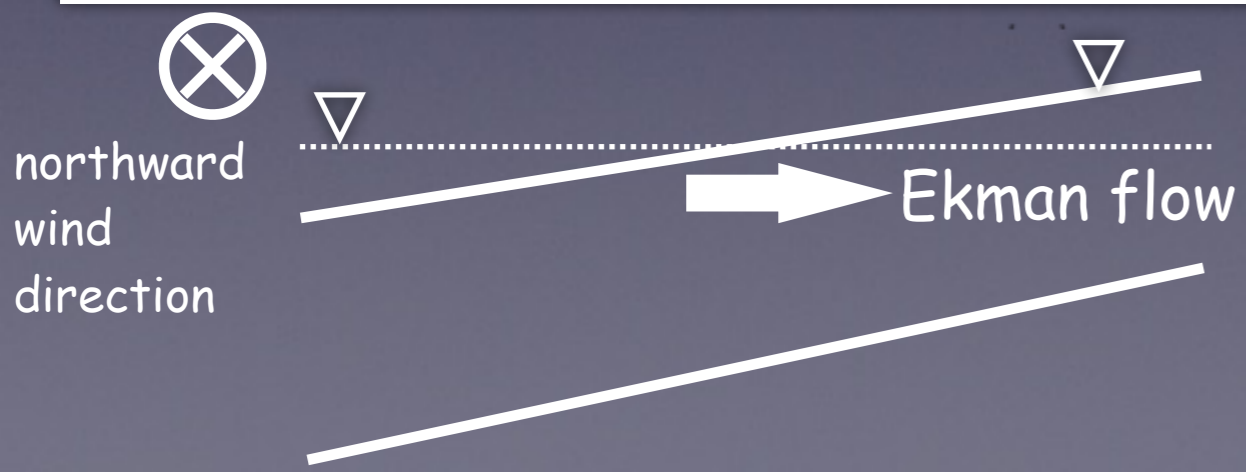
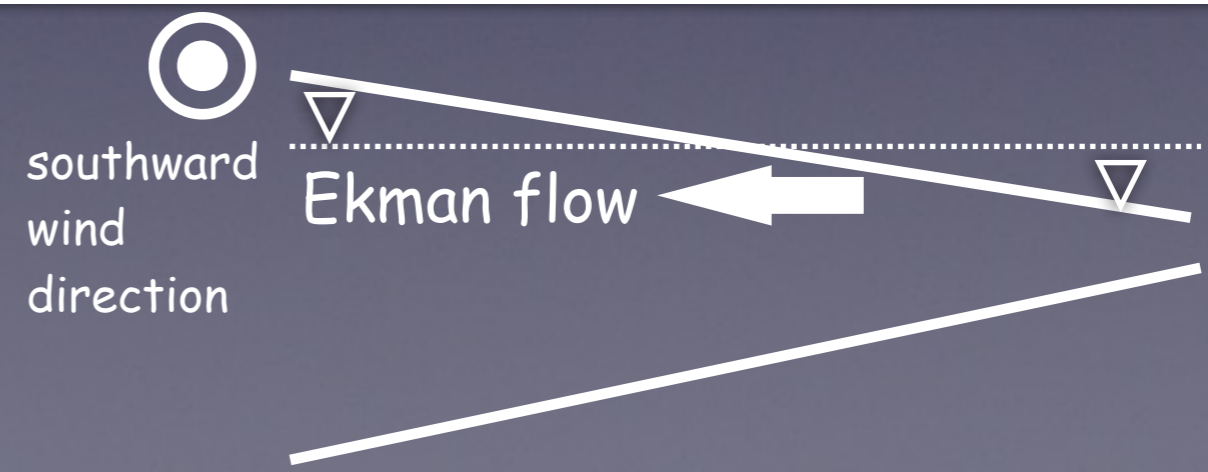
When the quantity of marine debris decreased (on July 15, 2015)
